Manhole Inspection Summary

Manhole # S59M__002MH

Insp Date: **11/7/08 11:42 AM**

Location Address: **odonnell st**

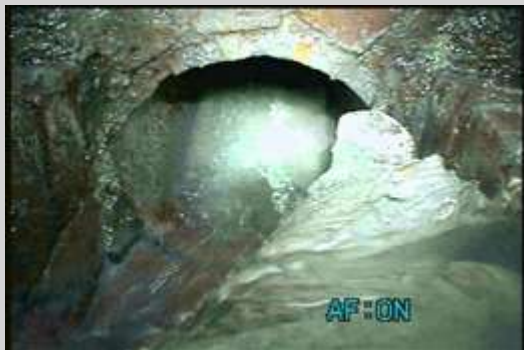
12 O'Clock Outflow

8 in. Circular Gravity Sewer
Pipe Out @ 12 OClock

Deposits: ☒ None ☐ Mud ☐ Sludge ☐ Debris ☐ Grease

Infiltration: **None** Pipe Seal Cond: **Unknown**

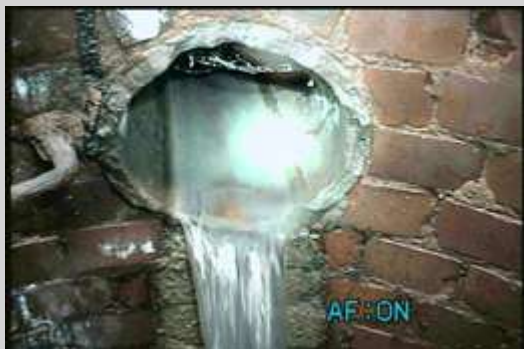
3 O'Clock Inflow

8 in. Circular Gravity Sewer
Pipe In @ 3 OClock

Drop In @ 3 OClock

Deposits: ☒ None ☐ Mud ☐ Sludge ☐ Debris ☐ Grease

Infiltration: **None** Pipe Seal Cond: **Unknown**

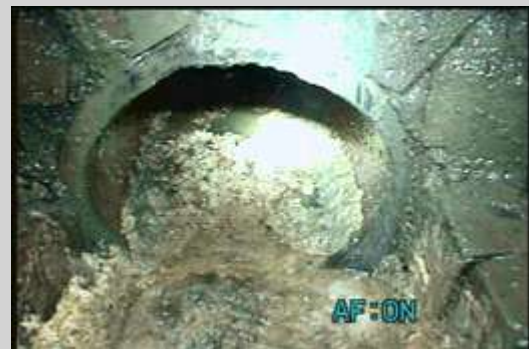
Drop: **Outside Direct**

Drop Condition: **Open**
